Tiny Bubbles Big Troubles: One Center's Solution to Eliminating Air Bubbles in the Return Line in Patients Weighing Less Than 16kg

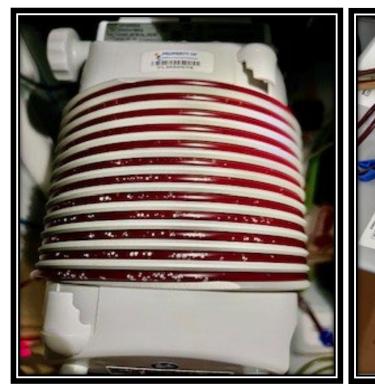
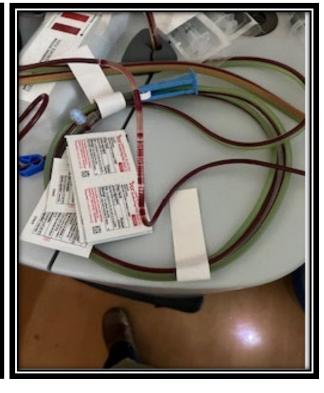
- Air bubbles from outgassing coalesced in the blood warmer tubing forming large air bubbles
- Air bubbles were found in 14 patients weighing less than 16 kg undergoing apheresis procedures
- Air bubble formed downstream from Optia's return line air detector
- Diligent operators discovered air bubbles prior to reaching the patient

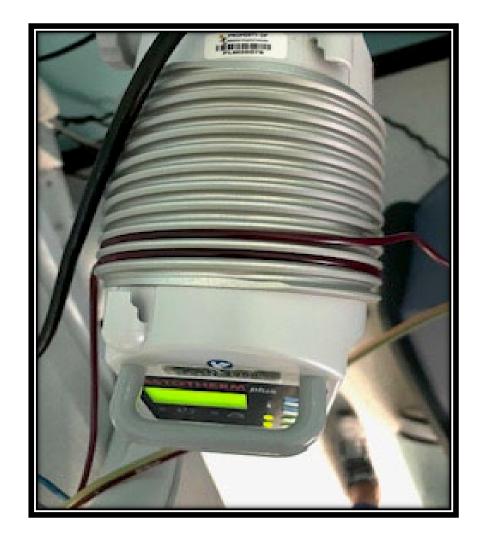
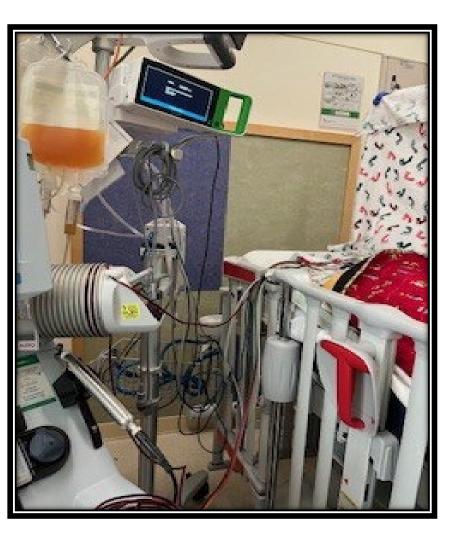
- In 11 procedures, air was manually removed prior to reaching the patient
- 3 procedures were aborted to prevent air from reaching patient
- All connections were securely tightened, the luer connection from the return line to the blood warmer tubing was not higher than 20 inches above the return access
- Corrective actions
 - Warm RBC unit used to prime circuit to room temperature by placing unit in ambient air for 1 hour
 - Blood prime rate 25 mL/min
 - Wrap blood warmer tubing around warmer 2-3 times
 - Place blood warmer parallel to the patient
 - Transitioned to horizontal SpectraTHERM blood warmer 04/2024

- Since implementing corrective measures, there have been no reports of large coalesced air bubbles in the blood warmer tubing
- Operators continue to vigilantly monitor blood warmer tubing for coalesced air
- The addition of an air detector monitor on the blood warmer tubing would be a beneficial safety device
