Metatarsal Fracture

CU ORTHOPEDICS - FOOT & ANKLE

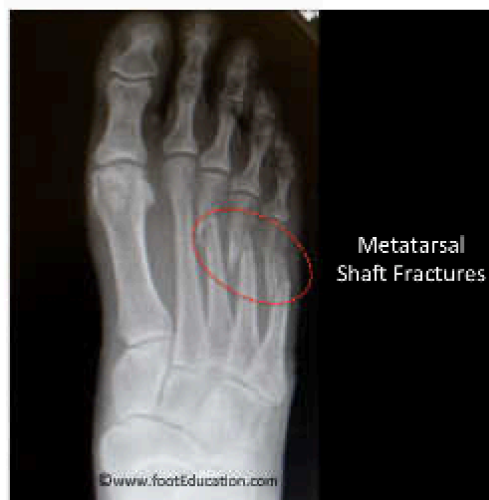
Figure 1: Metatarsal Fracture on X-ray

Plain x-rays of the foot will usually identify the fracture (Figure 1). The location and pattern of the fracture will be identified and assessed, along with the position of nearby bony architecture. The rotation and angulation at the fracture site are all things that the treating physician will need to consider. In the case of a metatarsal stress fracture, the original x-ray may be read as normal, so often a second x-ray is recommended when there is suspicion for a stress fracture. An additional x-ray 3-4 weeks post injury is helpful in identifying how healing is progressing in the affected bone.

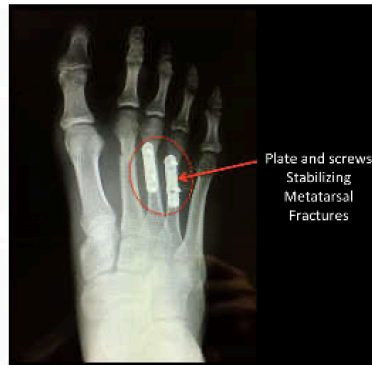
Figure 2: Surgical Stabilization of Metatarsal Fractures

Surgery may be indicated in the case of either a significantly displaced metatarsal shaft fracture, or in the case of multiple displaced metatarsal shaft fractures (Figure 2). There is some suggestion that surgical stabilization for a displaced metatarsal shaft fracture can produce a slightly faster recovery time, albeit with the associated risks of surgery. These risks include
