Safety of Supplemental Hardware Removal at the Time of Dorsal Spanning Bridge Plate Removal for Distal Radius Fractures

Cécile Harmange, MD; Charles Lockwood, MD; Fraser J. Leversedge, MD; Alexander Lauder, MD
Denver Health Medical Center, University of Colorado School of Medicine, Denver, Colorado

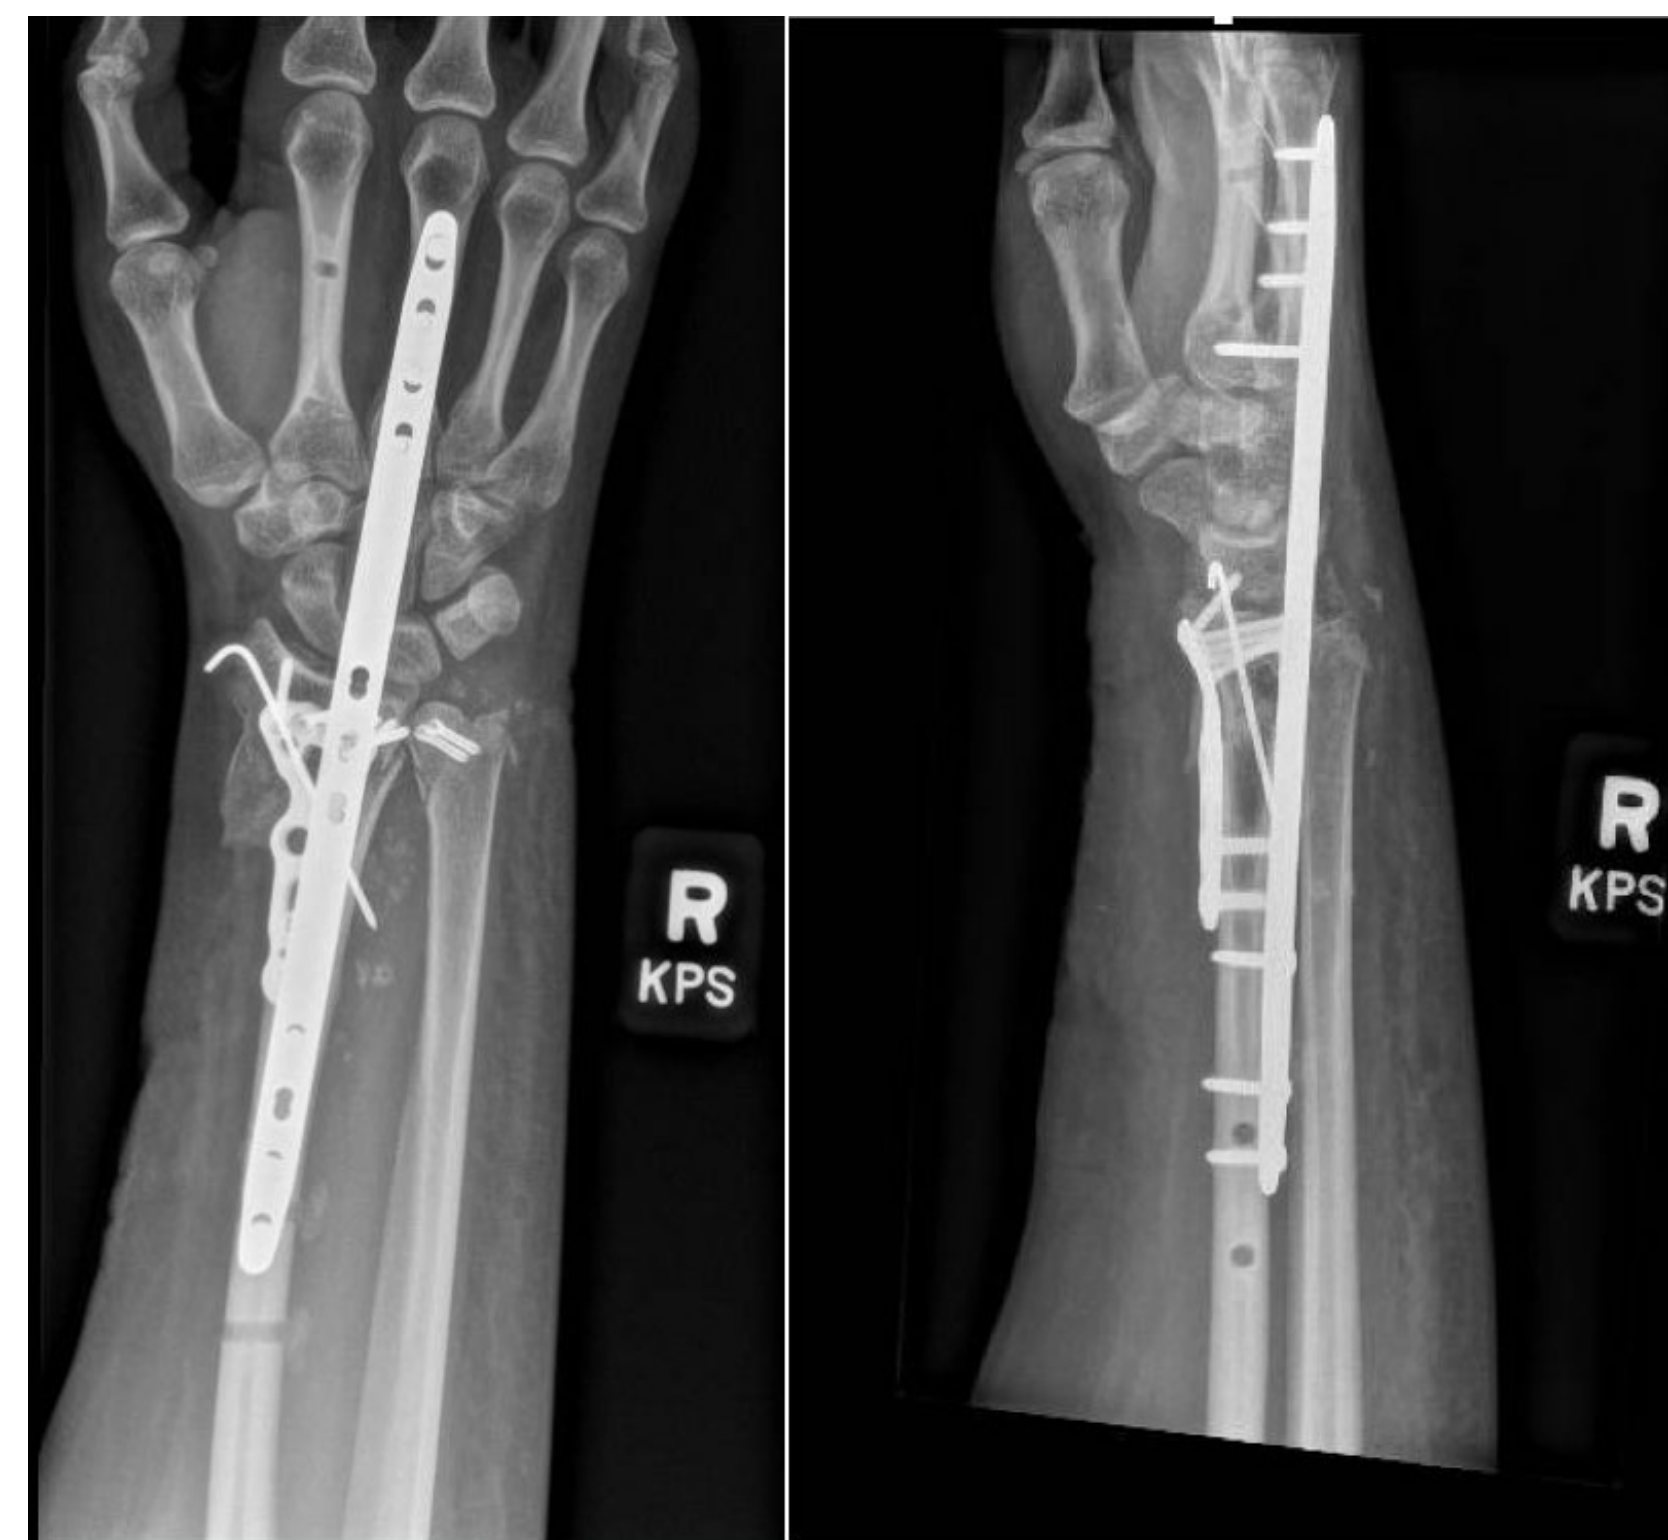
Figure 1. 37 yo w/ type II open distal radius fracture, treated with VLP, DSBP, and allogenic bone grafting

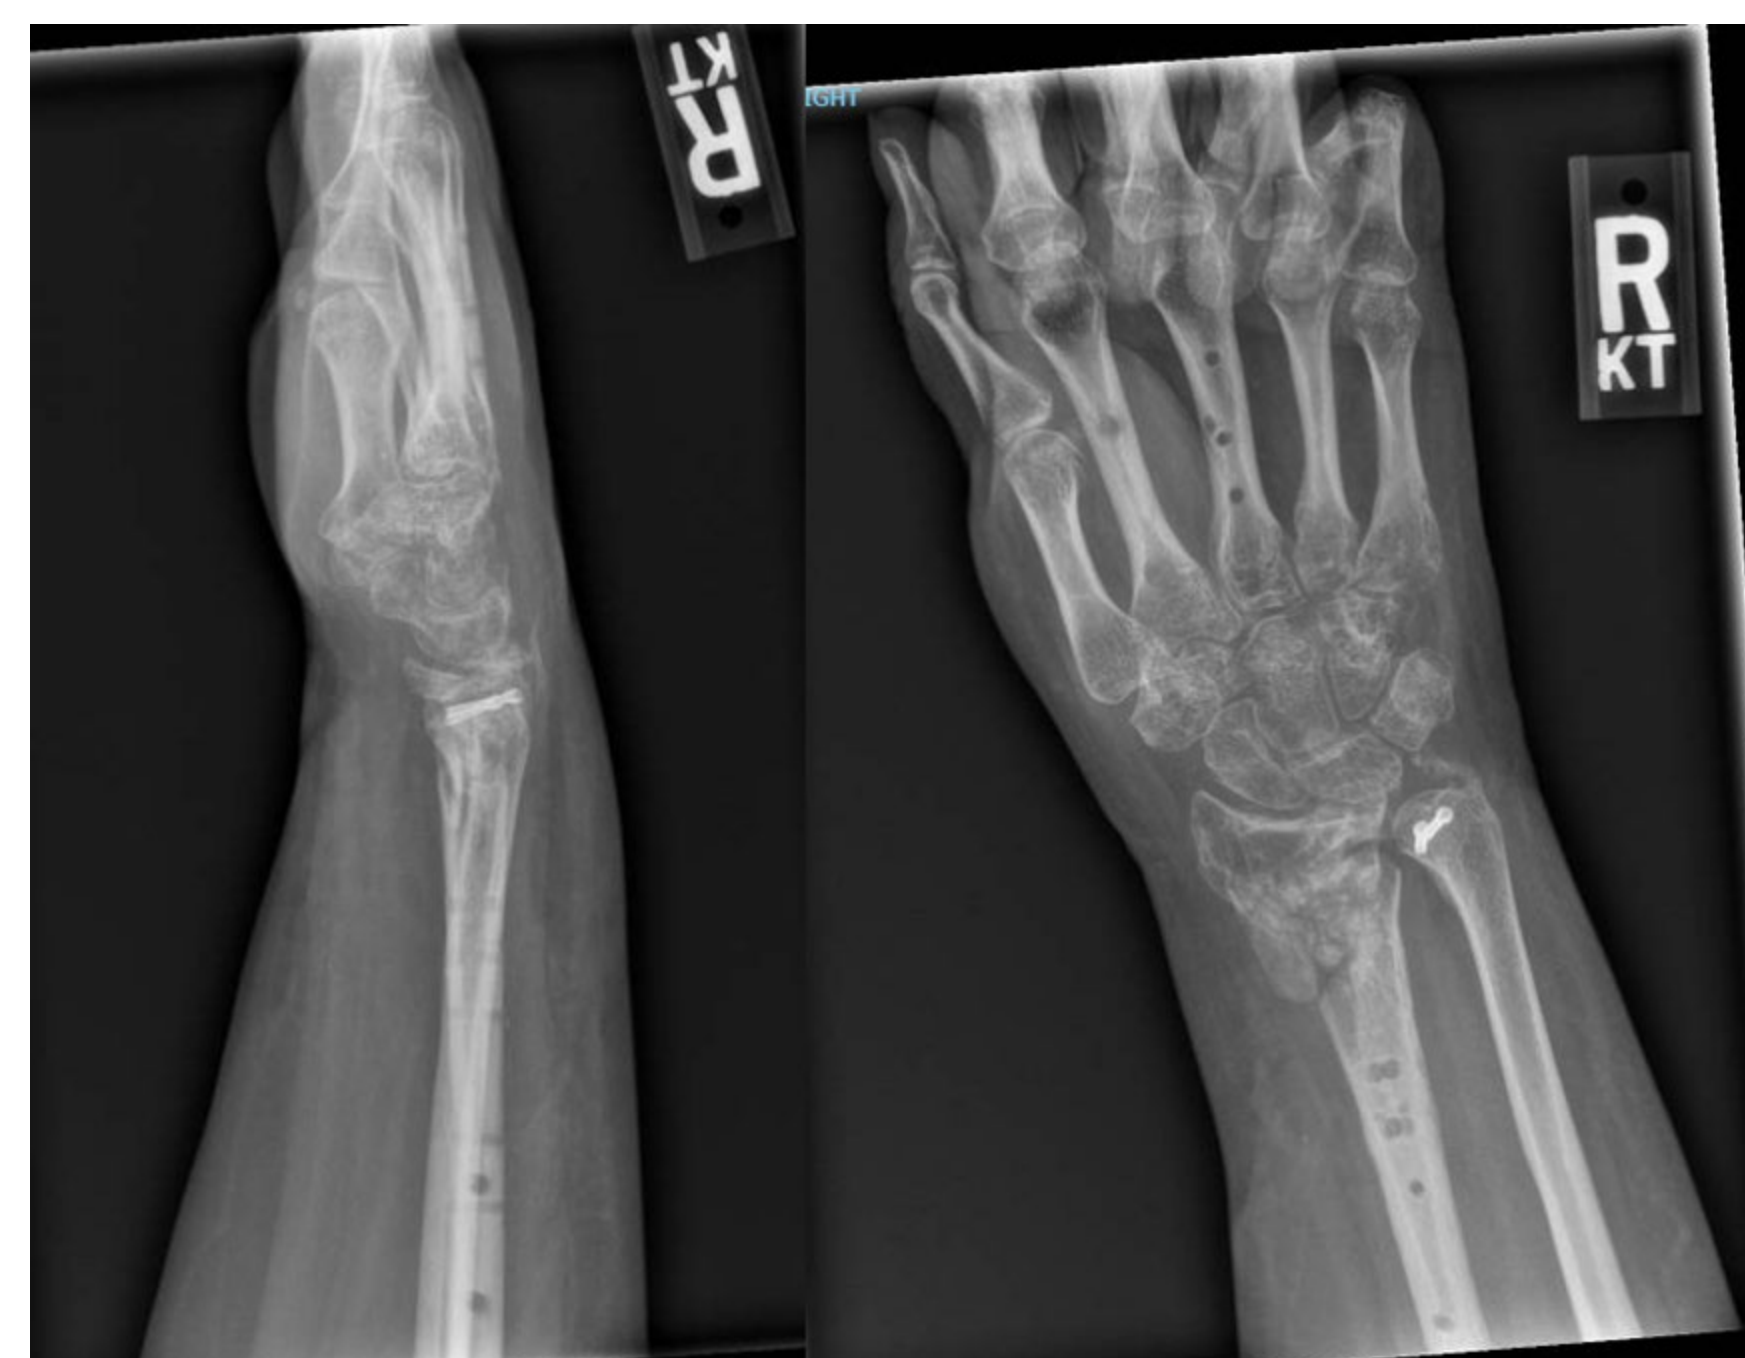
Figure 2. 6-week post-operative radiographs following removal of all hardware (4.5 months following index procedure) concerning for nonunion

2 patients with nonunion/delayed union were diagnosed intraoperatively with findings concerning for incomplete healing despite preoperative computed tomography (CT) imaging that suggested adequate osseous bridging.

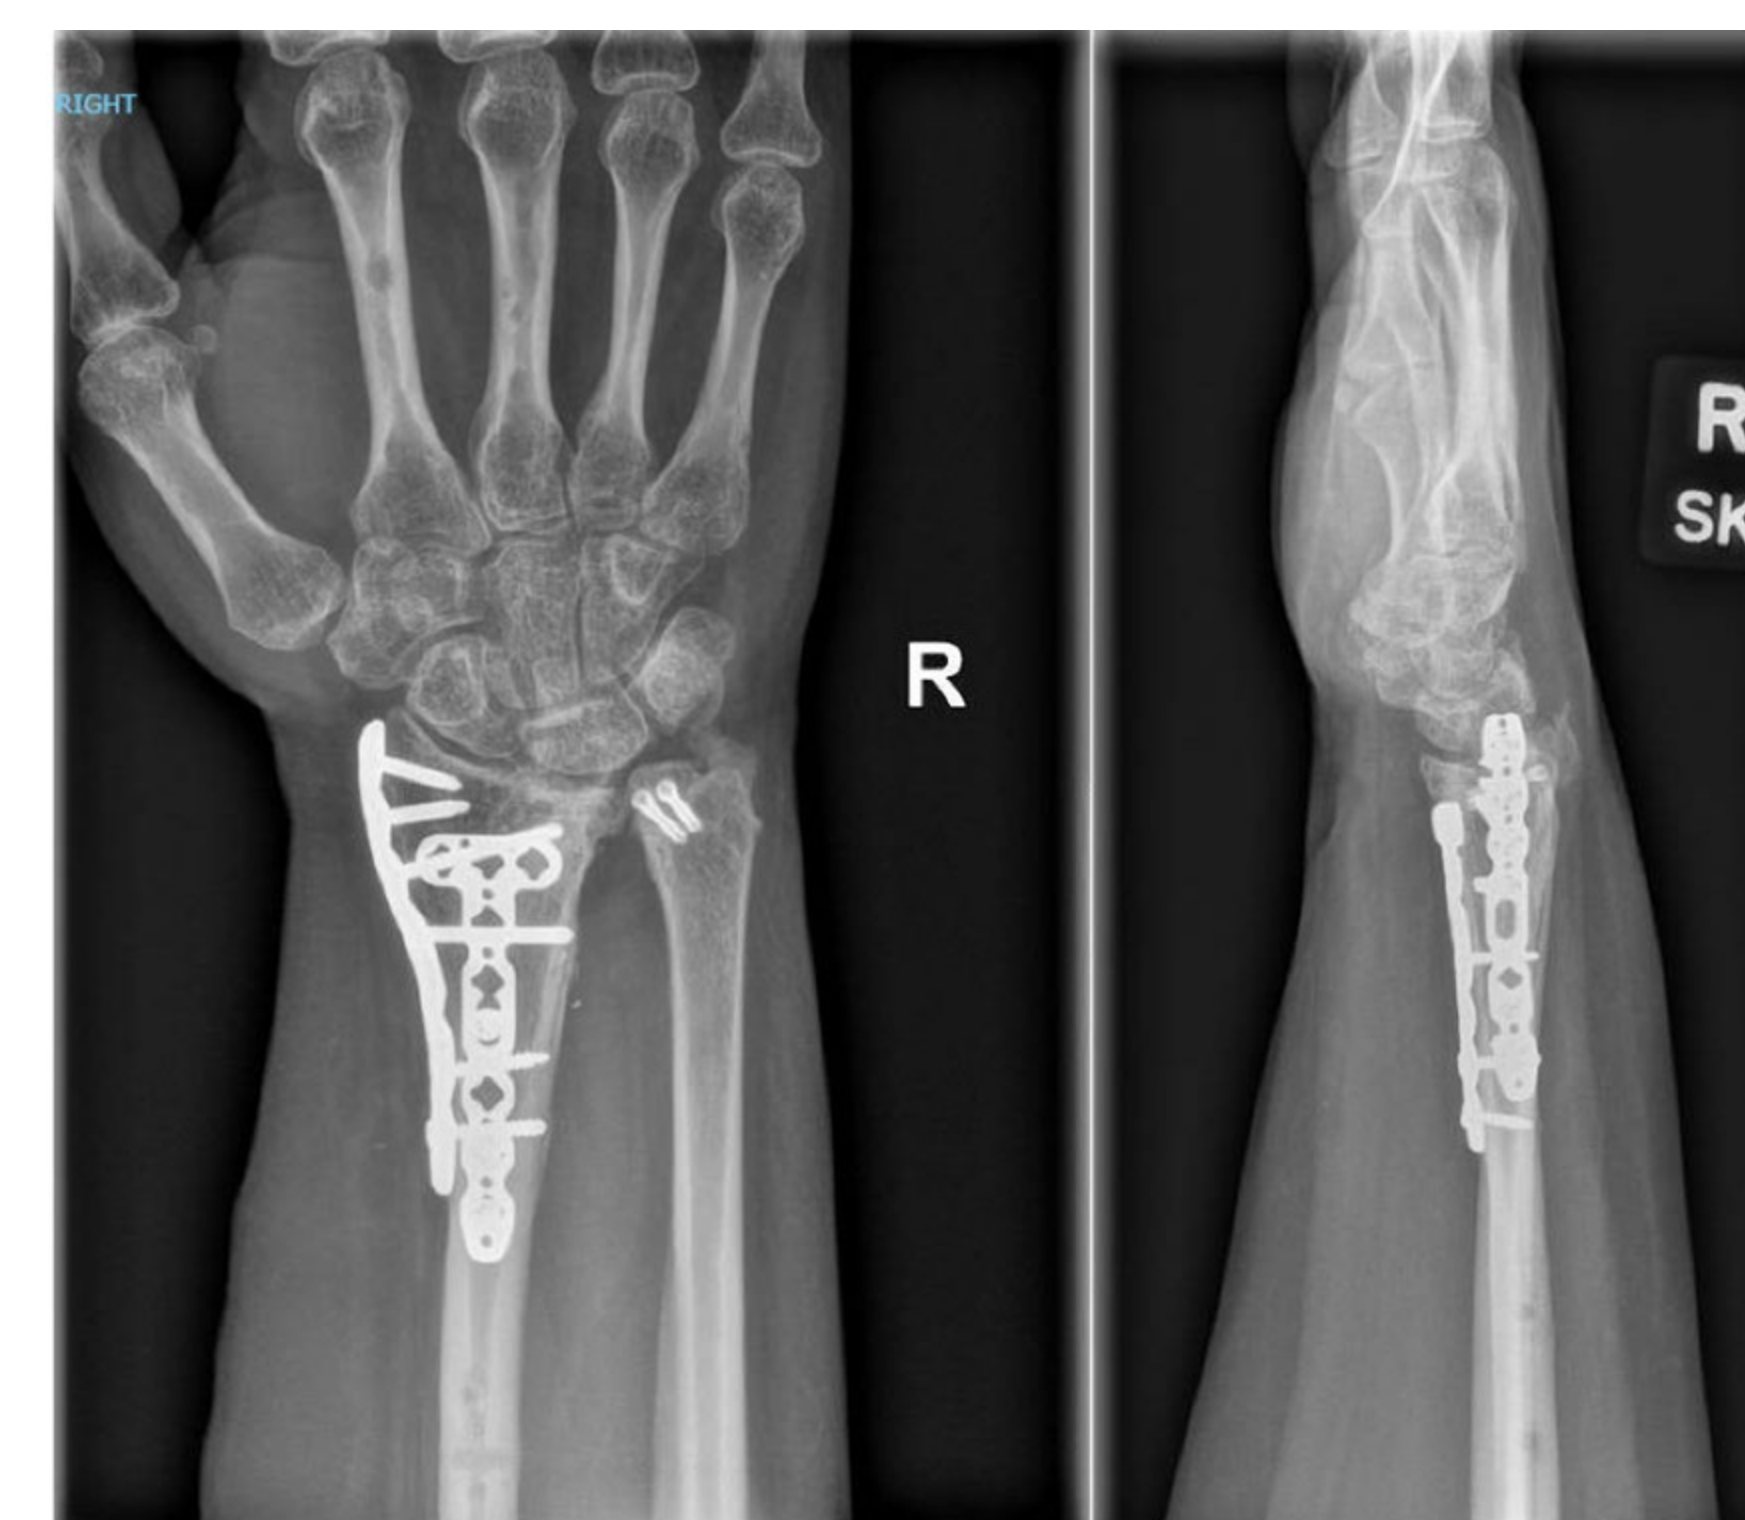
Figure 3. Secondary procedure for nonunion takedown, revision fixation with iliac crest bone autograft, radial column plate, and VLP
